Troubleshooting Firing Issue

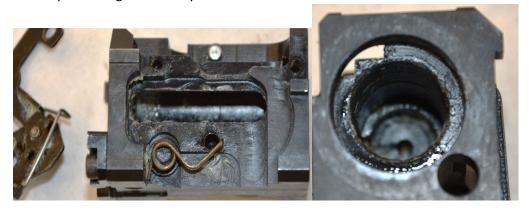
10. Wipe off any dust on all the components to check for any damage of the parts like the spring, stamped parts, firing pin, etc.

11. Clean up the firing block cavity.
